YORK SWIMMING POOL

Review of Pool Condition Reports

DATE: APRIL 2024

PROJECT NUMBER: 8822

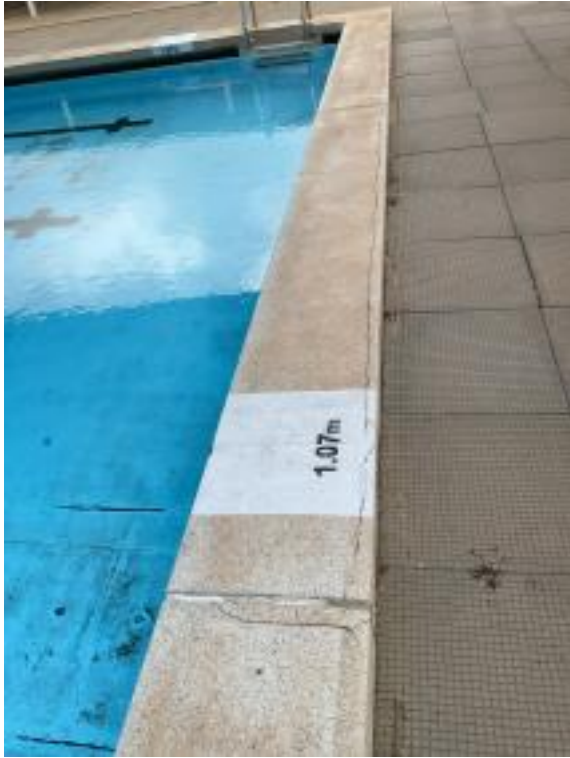
The concourse around the pool is significantly cracked. The perimeter concrete upstand has intensive vertical and horizontal cracks. The concourse settled in some areas.

Cracking in the concrete upstand

The cracks in the concrete, floor, walls, and upstand should be appropriately repaired as soon as they appear to prevent the chloride penetration of the concrete. The current stage of cracking in the concrete upstand to each pool requires a severe capital investment in further forensic investigation to confirm the ingress of chloride into the concrete, cement content, chloride diffusion and the extent of reinforcement corrosion. Depending on the results, the remaining life of the pool may be limited, simultaneously requiring a severe investment in the repairs.

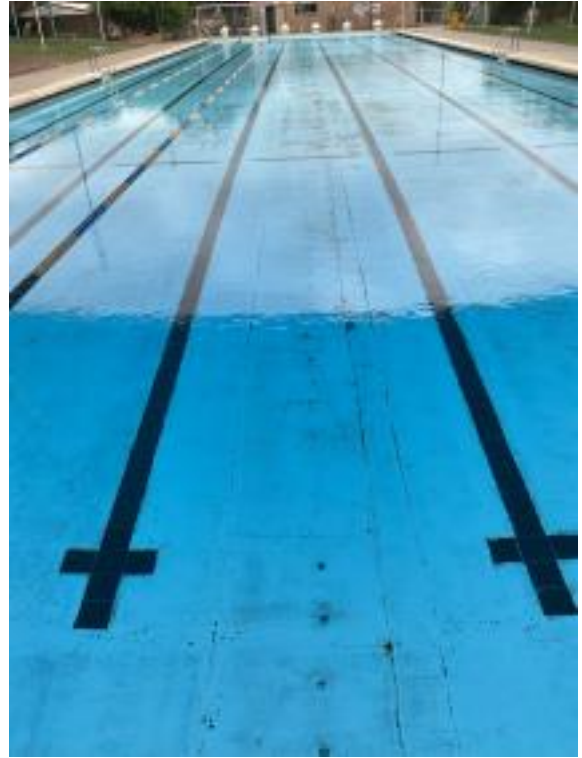
There are cracks in the pool floor along the return line and across with delaminated and discoloured paint and black stains.

Cracking along centre line

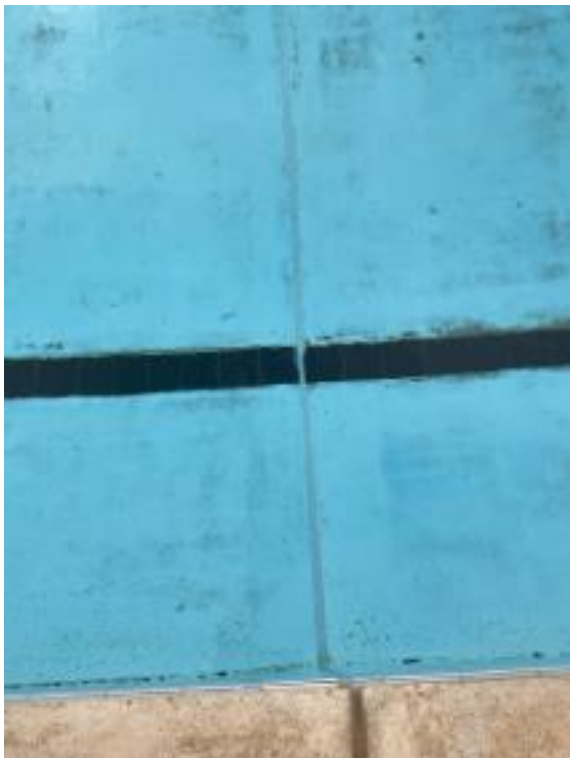
The different widths of sealant in the expansion joints in 50-meter pool indicate potential issues with the differential settlement on each pool section. If this is the case, sealant alone is a very short-term solution. Differential settlement can lead to concrete parts separating, widening expansion joints, damaging sealant, and ultimately causing water loss. This water leakage can further exacerbate issues by washing out compacted soil beneath the pool floor, creating air pockets and loose sand, which in turn contribute to continued settlement.

Different width of the expansion joint sealant

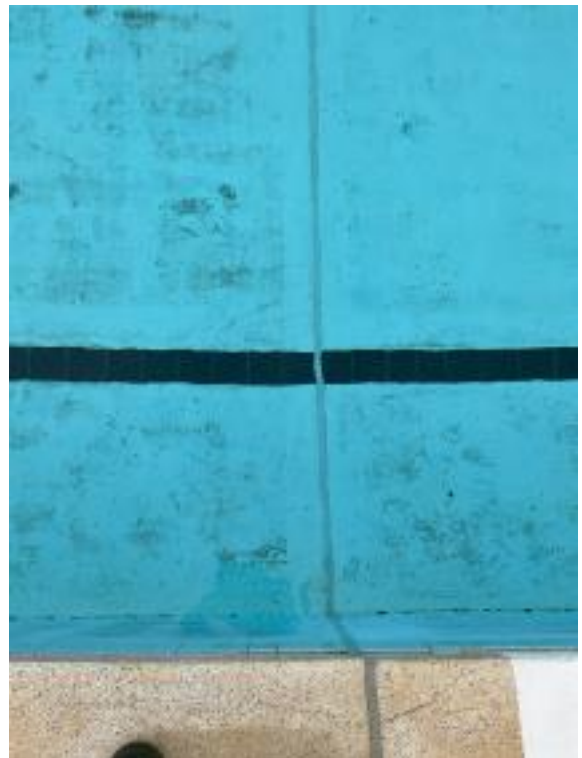
Cracking in the pool floor

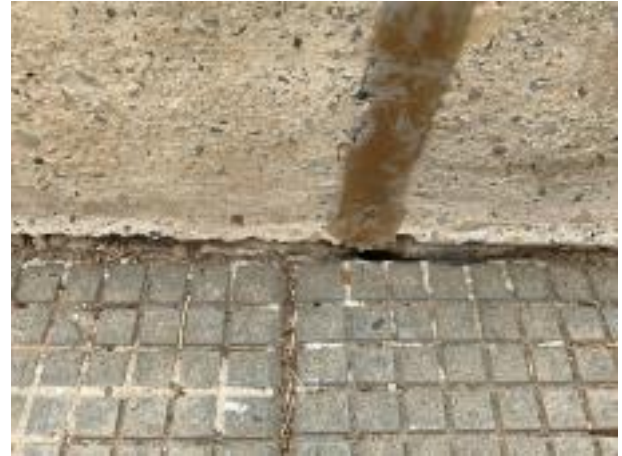
Settlement of the concourse

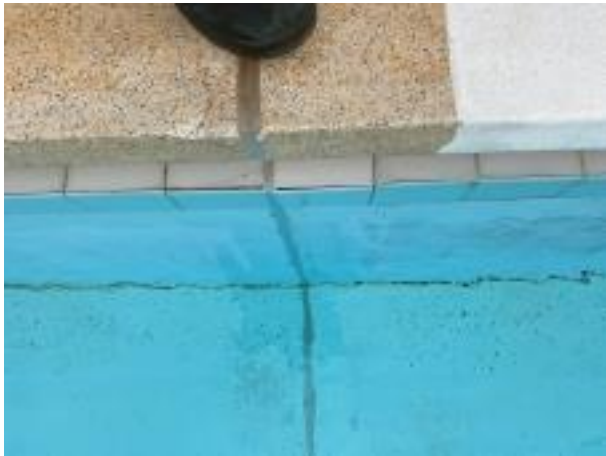
The tiling within the pools exhibits extensive wear, characterized by cracks, chipping, and debonding. This deterioration not only compromises the aesthetic appeal but also poses safety hazards due to the presence of sharp edges on the broken tiles, increasing the risk of injury to pool users.

Cracked and debonded tile

Considering the current condition of the tiling, it is advisable and feasible to undertake simultaneous re-tiling of all three pools. The total square meter area requiring renovation does not necessitate a significant investment. However, it is important to acknowledge the potential risk associated with this renovation process.

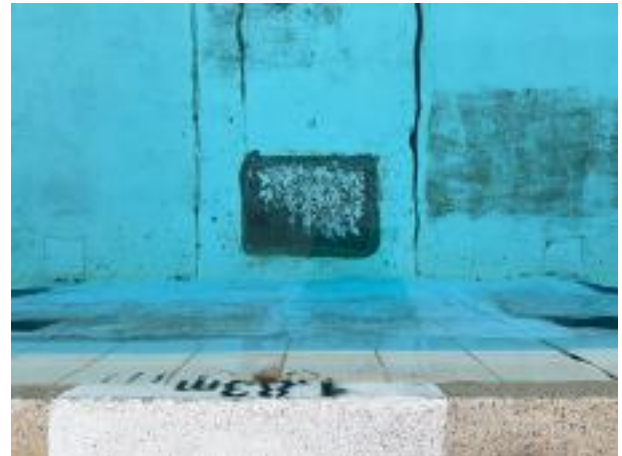
The number of repair patching was noticed mainly in the deep section of the pool.

Concrete patches at deep end

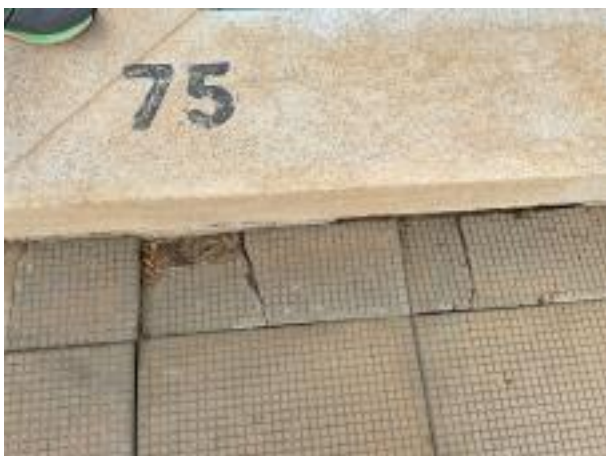
Concourse cracks and settlement

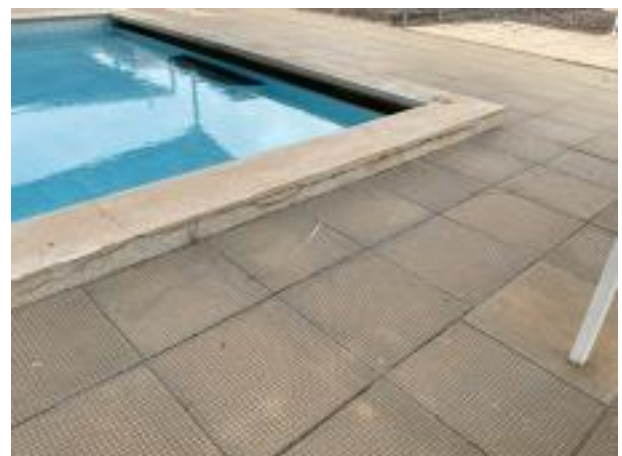
Concrete upstand cracking

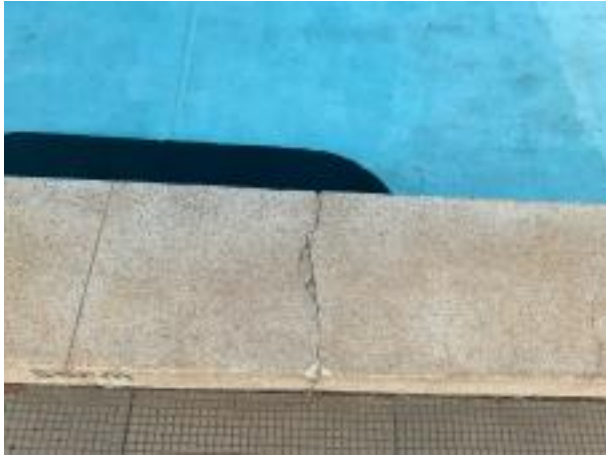
Concrete upstand cracking (no handrail)

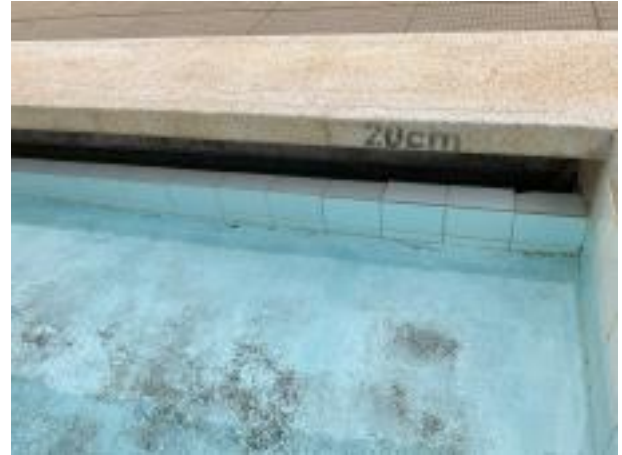
Debonded tiles and concrete upstand cracks

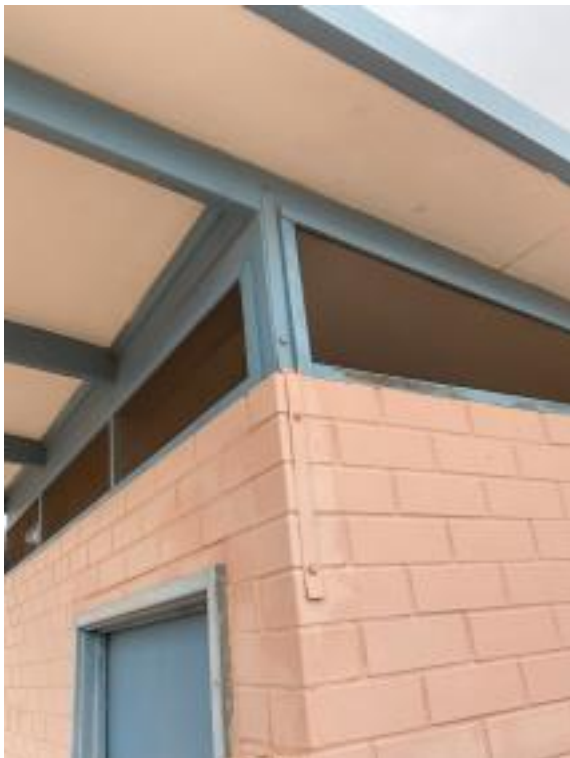
Insufficient tie-down

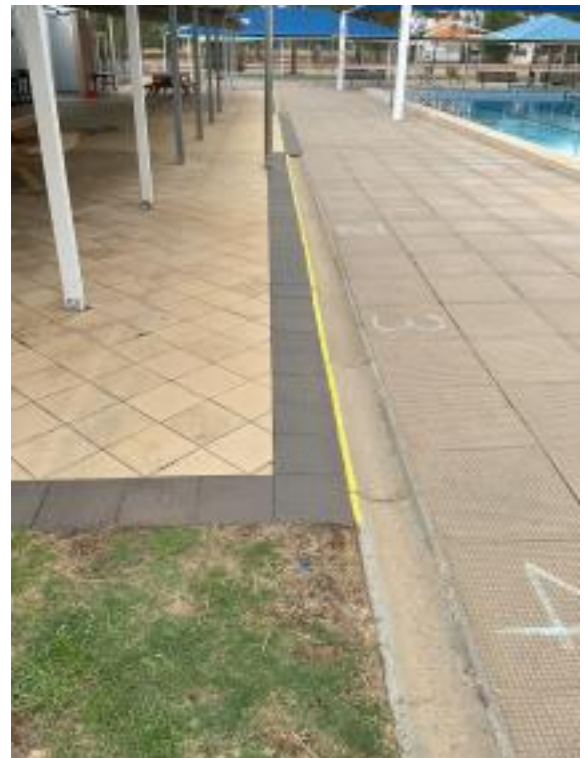
- The Concourse drainage channel is a trip hazard and causes safety and maintenance issues.
- The First Aid Room does not comply with the Department of Health Code of Practice for the requirements of the Design, Construction, Operation, Management, & Maintenance of Aquatic Facilities.
- There is no access or facilities for disabled people.
- The pool is out of level. The difference between the eastern side of the pool and the west is about 15mm.
- Cracking in channel gutter
- The water consumption of the pool was 2000 litres per hour in January 2019.
- The steps to the Toddler's Pool are too high, and handrails are missing.
- Originally, two strainer screens were present in the balance tank. Due to the failure of the concrete, one of the strainer screens retaining slots has fallen away, allowing only one screen to be used.

Concourse drainage channel – trip hazard

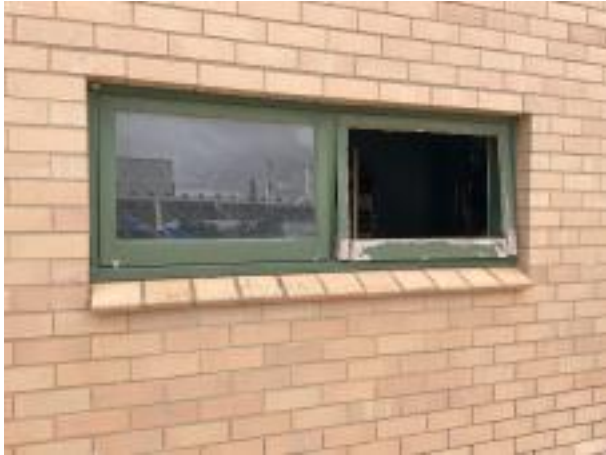
Broken window in Plant Room

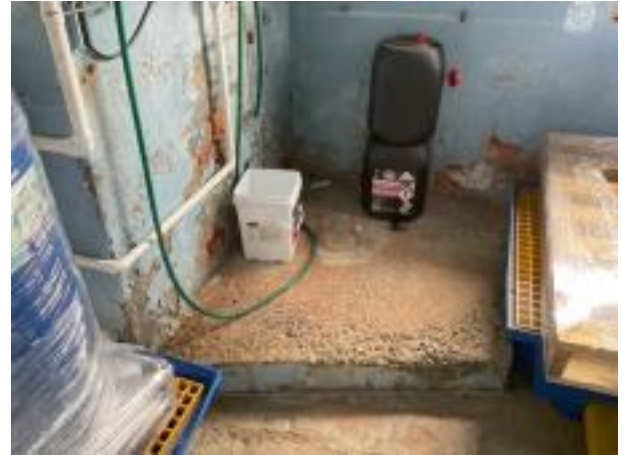
Degradated concrete plinth and brick wall

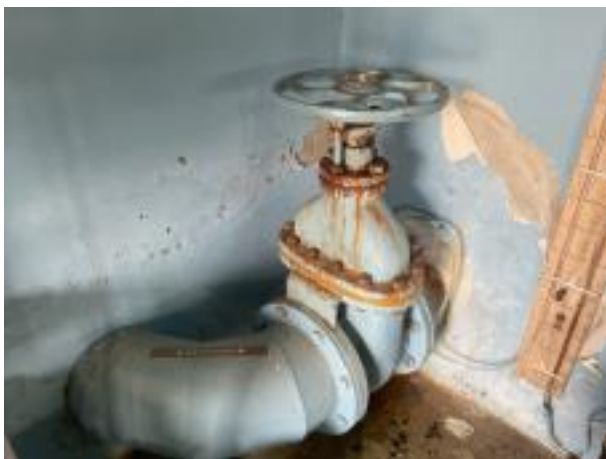
There is significant rust on the valve on the backwash line.

Rusted valve

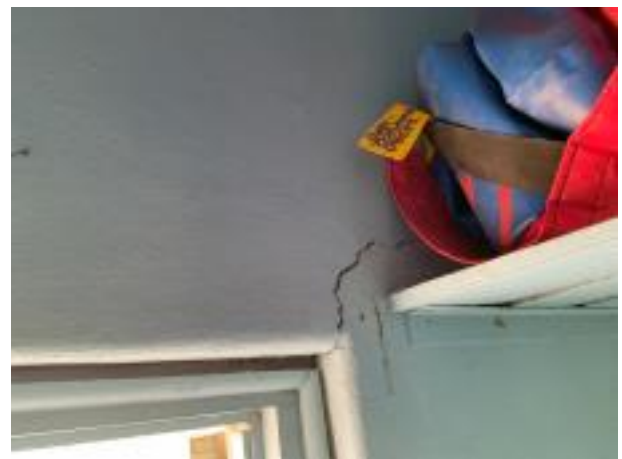
A significant structural crack is visible above the top corner of the entry door.

Structural crack above Plant Room door

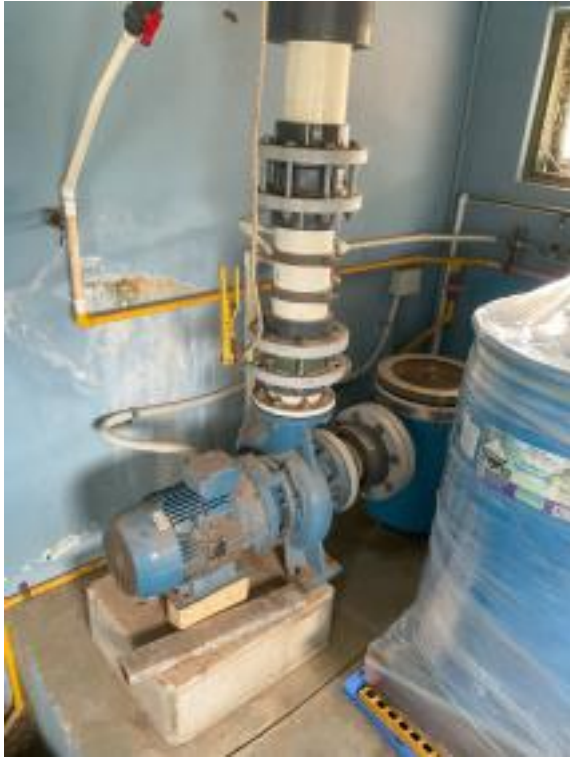
The old pump was re-used and repositioned slightly higher to accommodate the new piping. However, there is inadequate fixing with the pump bearing on the brick.

Insufficient pump fixing

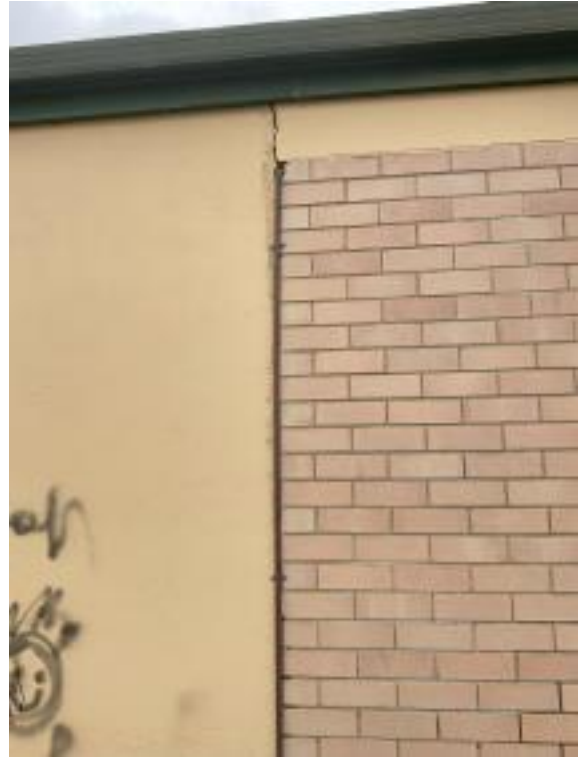
The brick Plantroom walls exhibit detachment from the concrete filter tank. There are some cracks in the brick walls in different locations and signs of chemical penetration into the plaster, timber elements, and paint inside the building.

Separation between Filter Tank and Plant Room

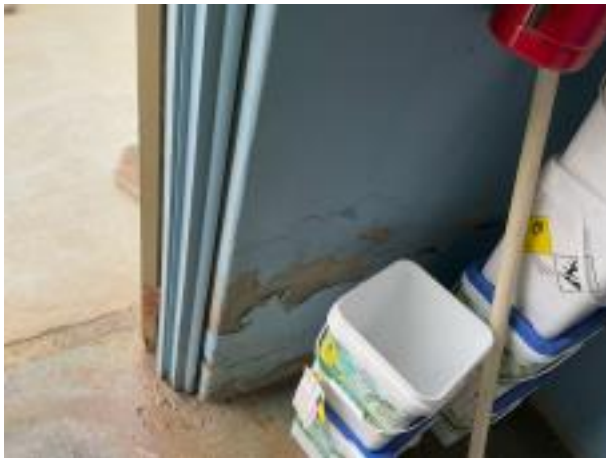
The Plant Room lacks mechanical ventilation, which causes chemical penetration in the paint, render, brick walls, timber elements, and pipes. Staying in the building is also unhealthy, as the chemical fumes enter the lungs. Broken glass in the window and large gaps in the opening don't improve the ventilation on unwindy days. The building structure requires an elementary repair to ensure it stays safe.

Plant Room wall damaged by chemicals

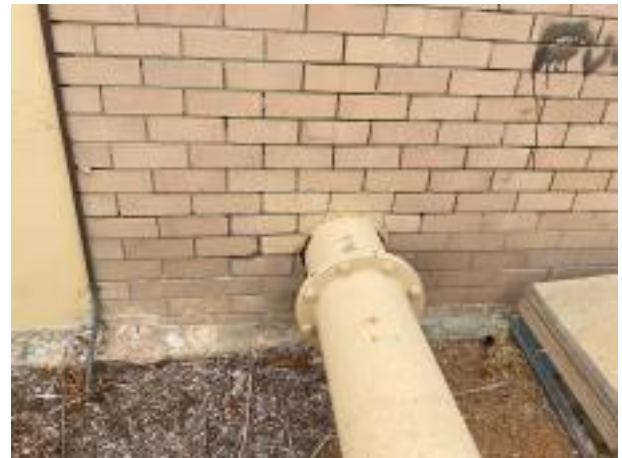
Damaged mortar around the pipe

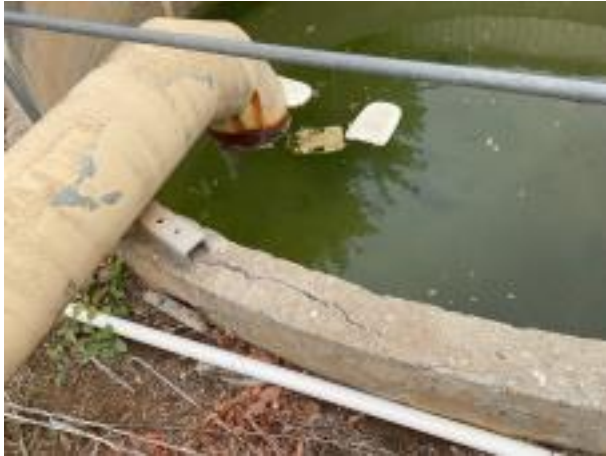
The Balance Tank and Backwash Tank are neglected and significantly damaged. Considering the advanced age of the structures and the extent of existing damage, a comprehensive renovation may not be feasible.

Damaged Balance Tank wall, rusted pipe and rubbish

The current debris and dirtiness should be immediately removed and tanks regularly cleaned. The dirt in the tanks causes bacteria and microorganism colonies, which enhances the demand for chemical treatment. As there is no automatic control of the water probes of water quality, the pool operator may react with delay, potentially endangering bathers who may ingest contaminated water or experience skin irritation. In severe cases, the pool may need to cease operations until water circulation is fully restored. It's noteworthy that a single filtration system serves all three pools, posing heightened risks to the youngest children.

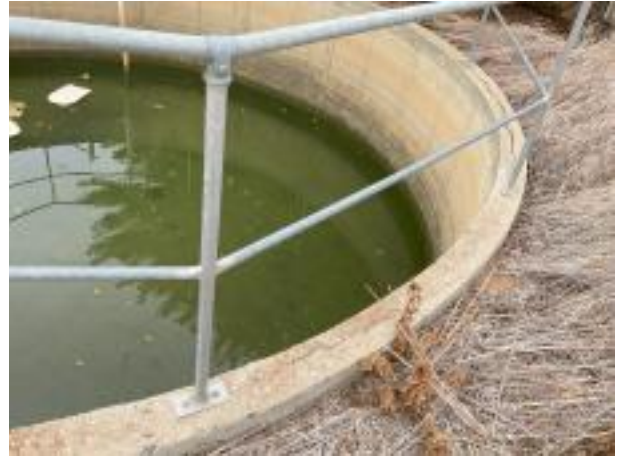
The concrete walls of the backwash tank exhibit severe damage, with exposed reinforcement, rendering the balustrade structurally failed and unsafe. Concrete debris and other types of rubbish were visible inside

Cracked wall and unsafe balustrade

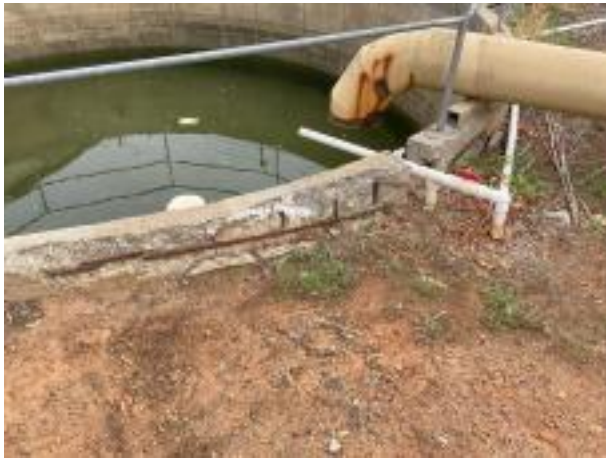
the tank. Chemical infiltration from the water storage tanks has led to the exposure of aggregate stones within the concrete structure.

Spalled concrete wall and rusted reinforcement

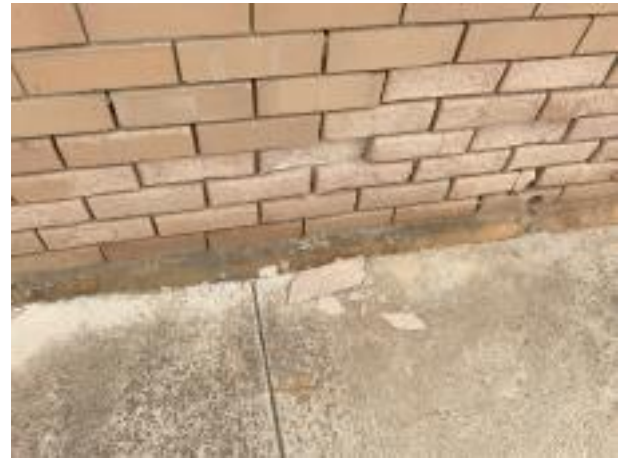
Spalled brick and lost damaged mortar

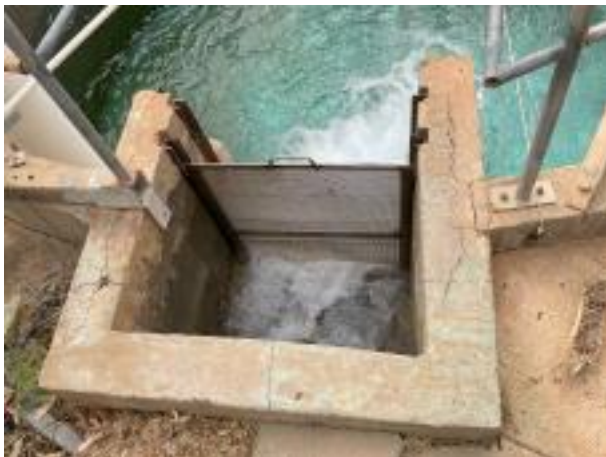
We've observed that a single strainer screen is currently in use. Due to the failure of the concrete edge, the remaining slot lacks the necessary support for a second screen. This issue results in inadequate debris trapping from the pools

Broken strainer screen (Balance Tank)

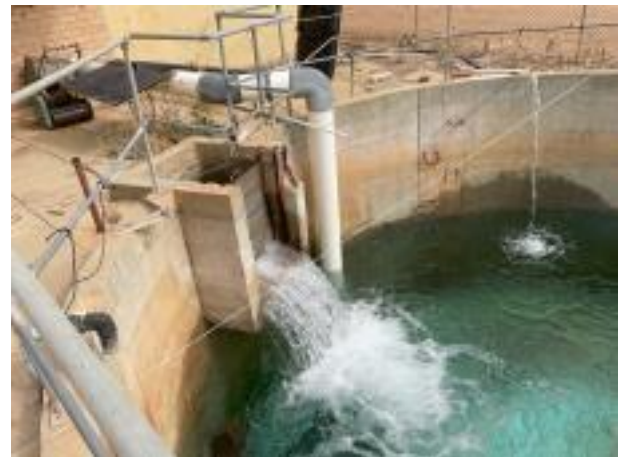
Damaged Balance Tank
